SPIRIT OF SUTTERBY PROJECT

Report on an Archaeological Excavation at Sutterby Church

23rd - 30th May 2015

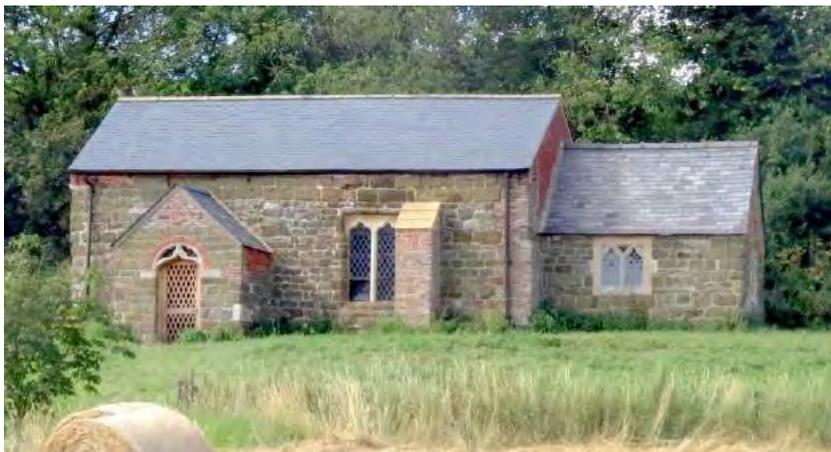
Fig. 2. South elevation of St John the Baptist's church at Sutterby

The church comprises a simple nave and chancel constructed from Spilsby sandstone with many repairs and alterations, some in brick. A photograph of the south elevation of the church is given and an outline plan is shown below. (Figures 2 and 3)

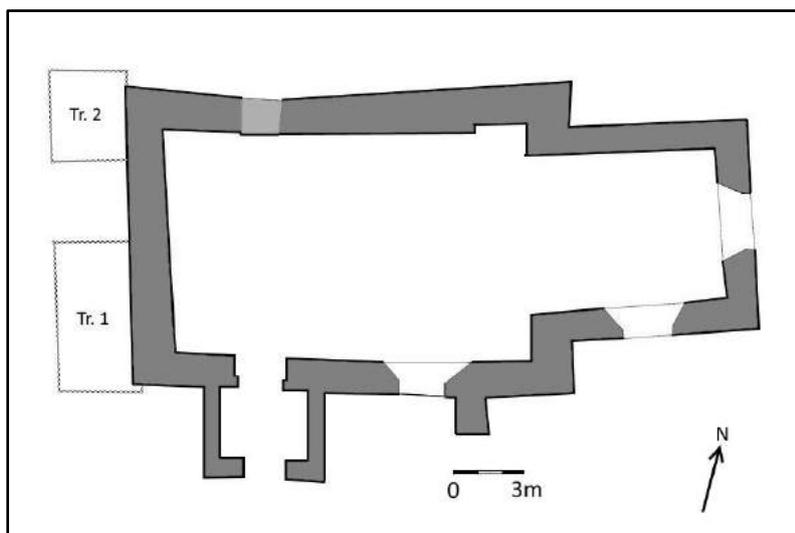
Fig. 3. Outline plan of Sutterby church showing position of excavation trenches

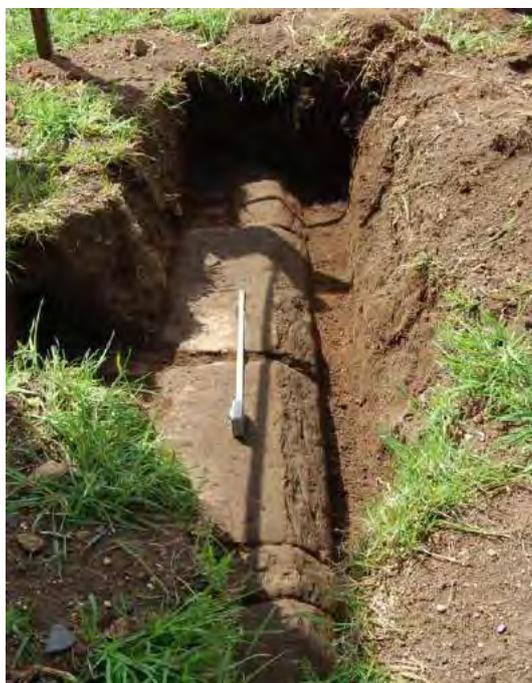
Fig. 4. Part of the row of chamfered stones as first discovered in May 2014 while probing for buried gravestones. [View looking south. The hand-tape scale has 40cms showing]

In May 2014, a team of volunteers was recording standing gravestones and surveying for buried gravestones by probing. While probing c. 2m from the west wall of the church, stones were detected and uncovered. Initially thought to be a fallen gravestone, what was subsequently discovered was a row of chamfered stones running north south which appeared to be the remains of an *in situ* wall. Further probing suggested that the feature extended the full width of the church. The initial view of the chamfered stones is shown below. (Figure 4)

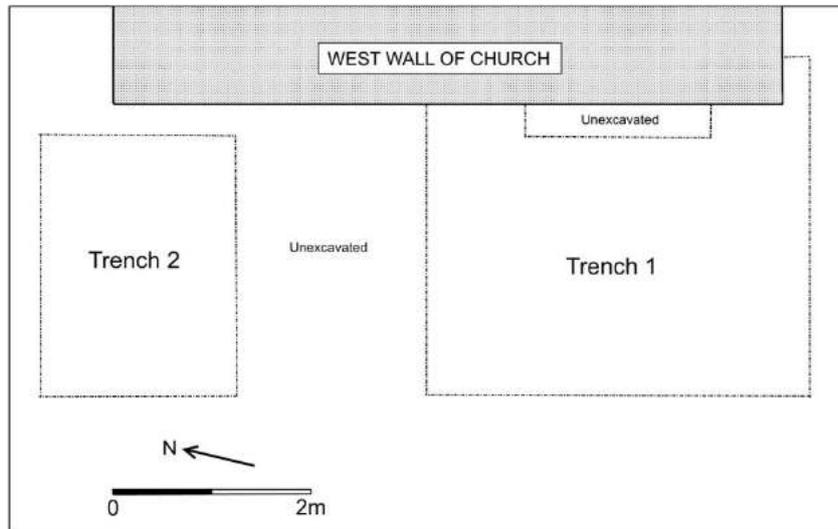
Fig. 5. Plan of excavation trenches

Two trenches were excavated, leaving a portion of the archaeology intact. A trench plan is shown below. (Figure 5) Trench 1 was nominally 4m x 3m and Trench 2 was 2m x 3m.

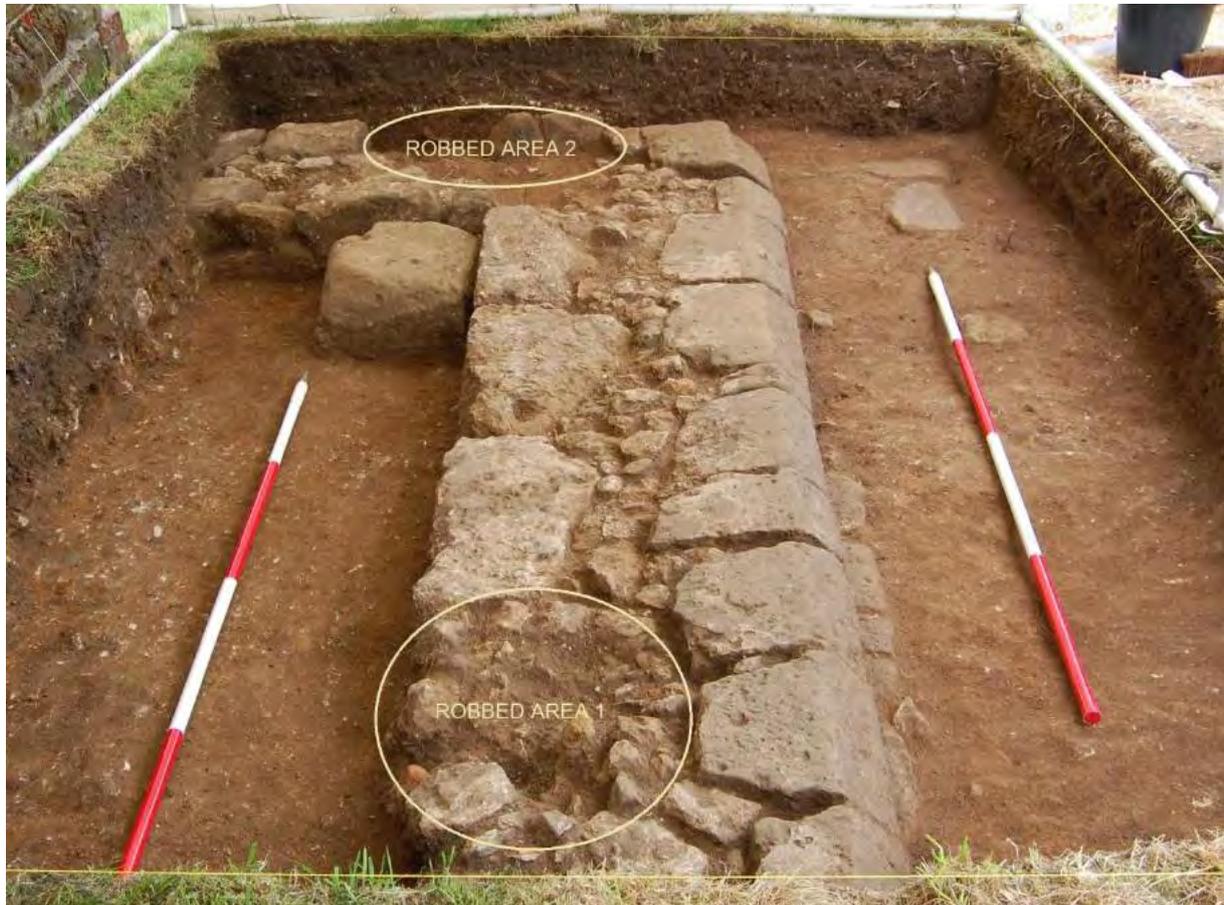
Fig. 6. Trench 1 (looking south) showing the excavated wall with chamfered blocks on the outside (west) and faced blocks on the inside. Two areas of stone robbing were evident. A large squared block of stone was found in the corner formed by the walls. [Scales are 2m]

In the corner formed between the west and south walls, was a large squared block of masonry. Its upper surface was smoothed and worn and its south east corner had a square cut section removed. It is probable that it had been made for some primary (unknown) function and reused in the corner of the church as a base or stand for something. The excavated wall in Trench 1 with the corner-stone *in situ* is shown below, followed by a detailed photograph of the corner stone. (Figures 6 and 7)

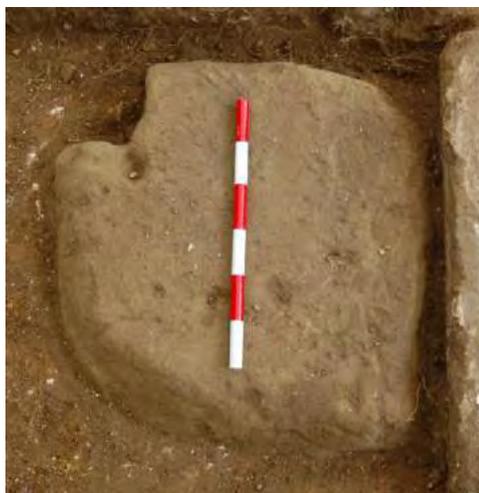
Fig. 7. Detail photograph of the stone placed in the corner of the excavated wall. (N at bottom) It is squared, but much worn, and has a square portion cut from its south east corner with a small circular depression adjacent to its corner. Note how close it sits to the inner stones of the west wall. It is presumed to be a reused stone, serving as some form of base or pedestal. [Scale is 30cm]

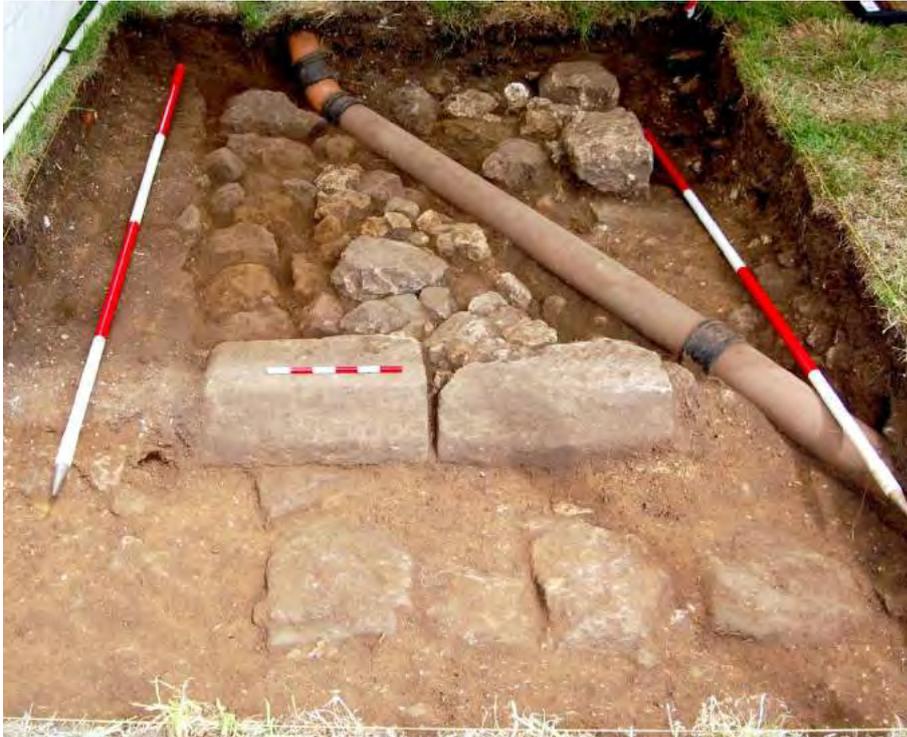
Fig. 8. Trench 2, showing the two surviving chamfered blocks - the left hand is chamfered to form the corner, but no worked stones survive on the north wall return. A line of rough stones were at too high a level to be a foundation for robbed chamfer stones and probably belong to an earlier phase. Note the two surviving faced blocks from the inner wall face (top right). [Photo looking east - scales are 2m and 30cm]

In Trench 2, a pipe trench containing a 100mm ceramic drainpipe had destroyed much of the archaeology. It ran from a rainwater gully at the north west corner of the church diagonally across the trench. The pipe had been installed as part of a repair programme carried out in 2002 to solve severe rainwater problems. Only two chamfered blocks from the west wall remained *in situ*, including a block chamfered on two angles forming the north west corner. On the inner face, two faced blocks survived from the inner north wall. There were no faced or chamfered stones forming the return on the north side. (Figure 8).

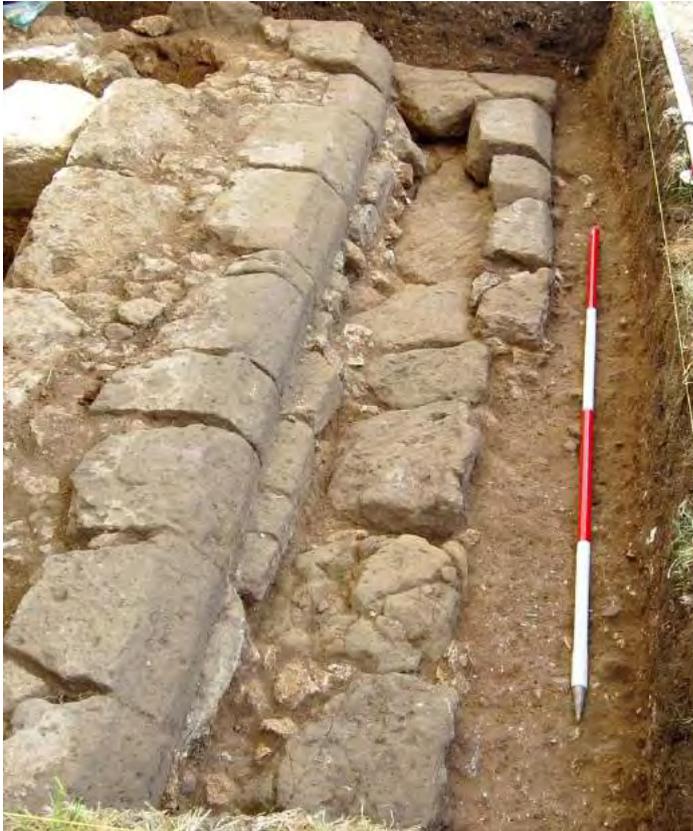
Fig. 9. Trench 1 (looking south) showing a second remnant row of five stones (some chamfered) located below and 0.6m west of the first wall. These in turn overlie a third row of (roughly squared) stones which may form an earlier foundation. [Scale is 2m]

With the chamfered stones fully exposed in Trench 1, the surfaces of several other pieces of worked stone were evident in the excavated surface to its west. Initial thoughts were that these might form a surfaced path around the end of the church and excavation continued in order to expose the feature. However, it was soon clear that the stones might be a remnant of a second chamfered wall base c. 0.6m west of the first, (c. 2.7m west of the standing wall) (Figure 9).

In both trenches, a row of roughly squared stones was discovered below and c. 0.5m to the west of the upper chamfered row. This row, which is potentially a wall foundation, is aligned through the central baulk and forms a gentle slope dropping 0.5m down the length of the course (Figures 9 and 11). The deposits excavated 'outside' the church wall were generally homogenous and features that were expected to be present (e.g. foundation trenches for the standing wall or the stone footings) were not detected.

A structure represented by the stone foundation that cuts the Phase 1 burial. (Figures 9, 12 and 17). Possibly Sutterby's first stone church.

Phase 2b (north-south wall foundation) is evidenced by the row of roughly squared stones located in Trenches 1 and 2. (Figures 9, 11 and 16) Based on their alignment and recorded

Phase 3 west wall: The external blocks were set on a narrow, irregular step foundation which may have been underpinned by buried masonry from the Phase 2 foundation. (Figures 23 and 9) The internal faced blocks were set on a step foundation of two courses in a similar fashion to the south wall. (Figures 21 and 24)

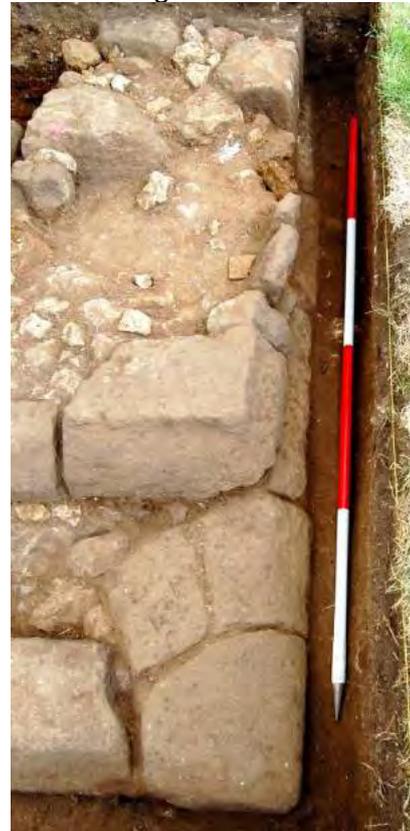
Fig. 10. Trench 1 looking east along the line of the south wall. The possible second chamfered wall appears to run under the first shortening of the wall and probably runs under the existing standing south wall. [Scale is 2m]

Five stones from this course survive at the south end of the west wall. Only the corner stone and the second stone are convincing wall masonry and, seen alone, this row of stones seems superficial. But when the lower courses of the south wall are examined, there is a possibility that these stones are continuous with the chamfered course that underlies the later wall and presumably also the standing south church wall (Figure 10).

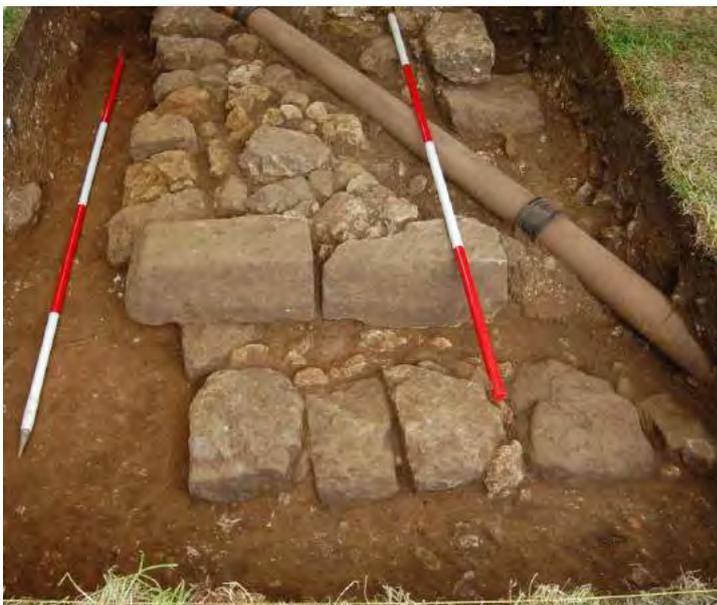
Fig. 11. Trench 2 looking east showing the two chamfered blocks with a row of roughly squared stones (stratigraphically below them) in the foreground. [Scales are 2m]

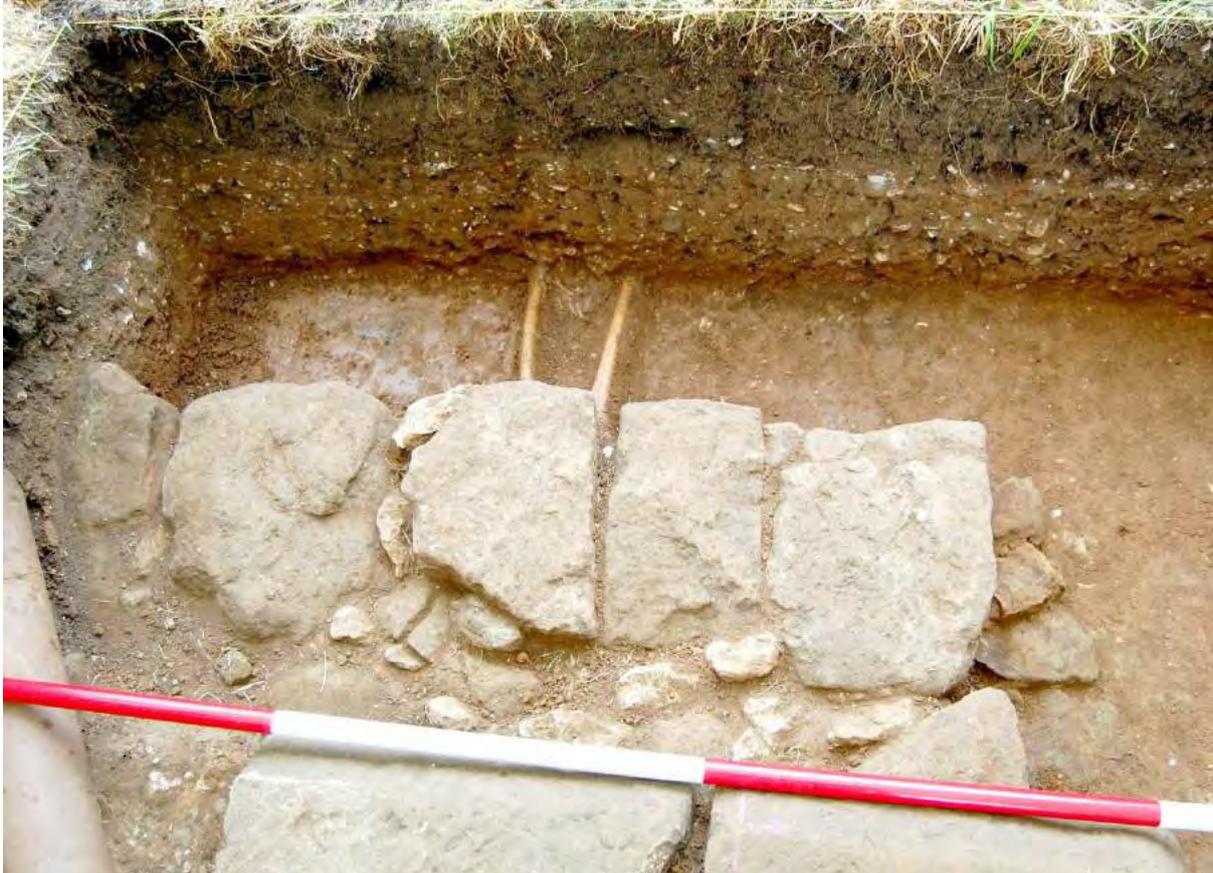
Fig. 12. Two femurs from a medieval inhumation protrude from the western section of Trench 2. The pelvic bones are under the section. The femurs had been truncated at the knee joint by the construction of the stone foundation. The inhumation was discovered 50-55cm below the modern ground surface. [Scale divisions are 0.5m]

On the final day of excavation (Day 7) an inhumation was discovered in Trench 2 which was cut through by the construction of this foundation. (Figure 12). The body was laid east-west (head to the west) and the trench section was dug at the point where the tops of two femurs met the pelvis. A group of what appeared to be metacarpals or proximal phalanges was noted in the pelvic area as if the body had been laid with the hands crossed over the pubis. (Figure 13) The femurs had been truncated just above the knees by the construction

The stones are parallel to the line of the existing west wall of Sutterby Church. They do not exhibit any mortar between them or remaining on their upper surface. They were not lifted and it is thus not possible to establish whether they lay over another course or on hardcore, but in some places it is clear there are intentionally laid stones beneath. (Figures 12 and 13)

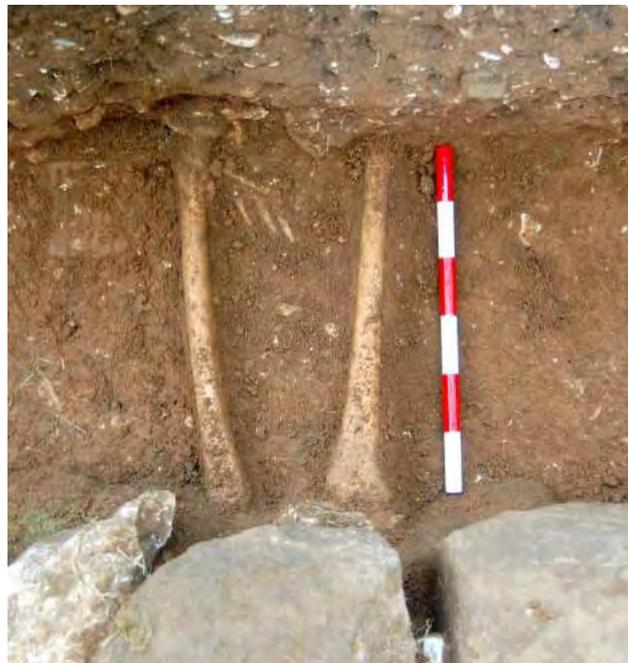
Fig. 13. Detail of the truncated femurs in Trench 2. Note the finger/hand bones across the pelvic area. The stone foundation cuts the bones just above the knee.

Phase 1 is evidenced by the partial inhumation found in Trench 2, which had been cut through by the construction of the earliest stone footing discovered. The burial was located c. 0.50 - 0.55m below modern ground level. It was aligned east-west with the head to the west in the Christian tradition. (Figures 13 and 15)

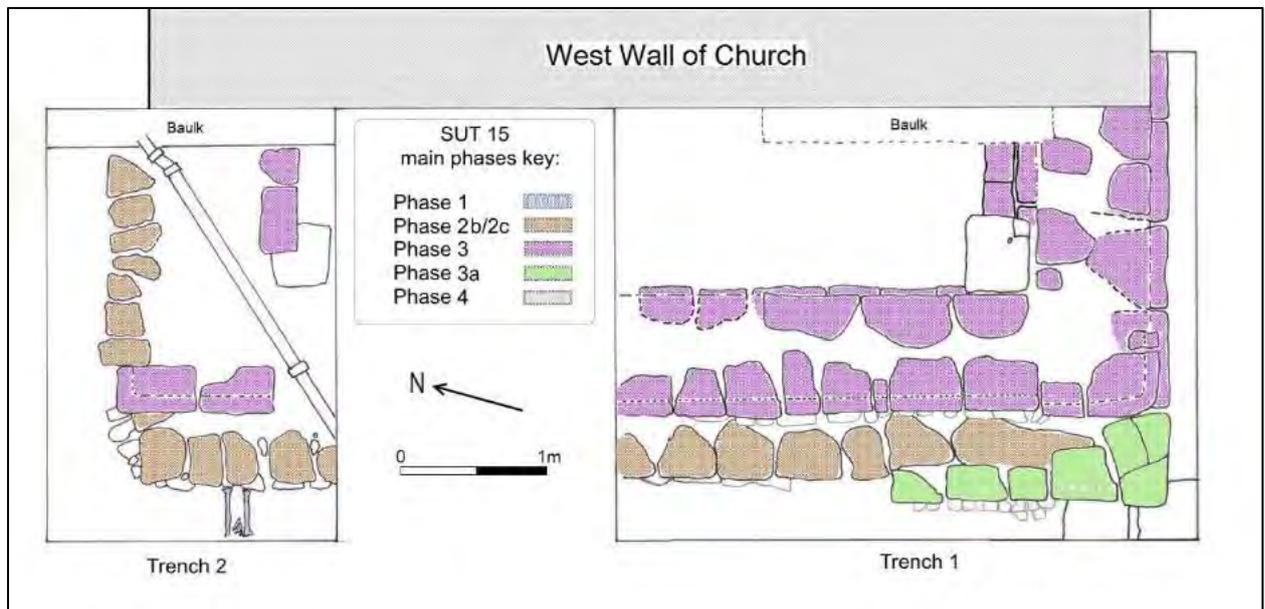
Fig. 14. Plan of Trenches 1 and 2 showing all the excavated features with the main phases defined in colour.

The excavation identified several phases of activity which offer an interpretation of the sequence of events evidenced by the archaeology. A plan showing all the features discovered, with the main phases coloured, is given below. (Figure 14). Description and analysis of the phases and possible dating follows.

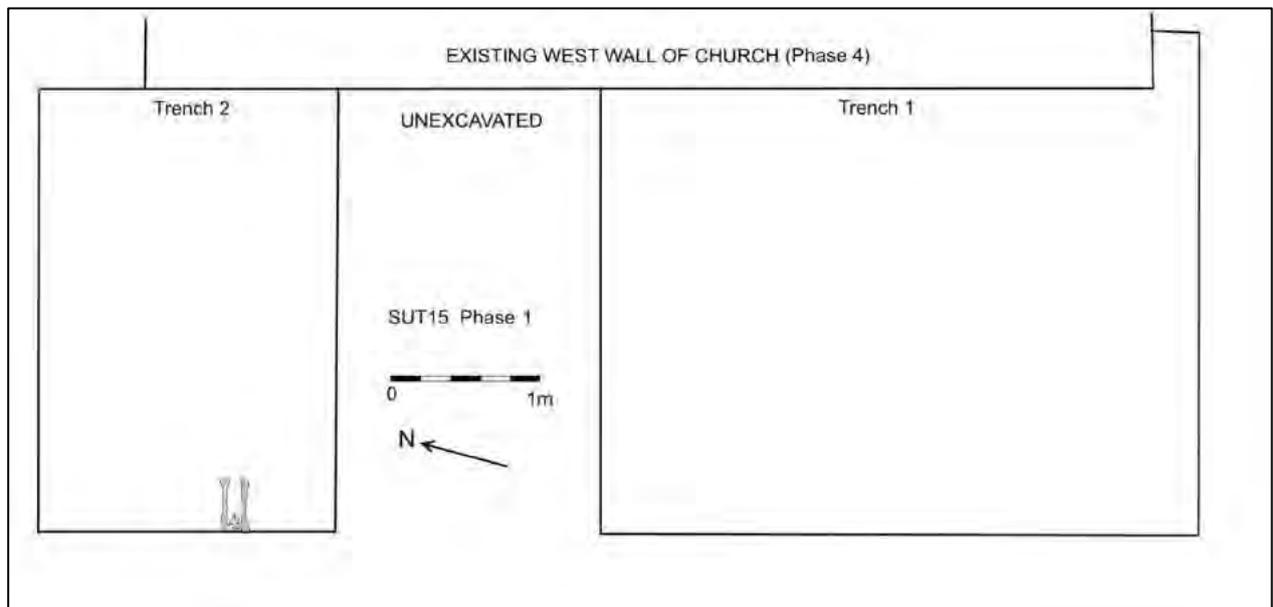
Fig. 15. Archaeological features relating to Phase 1 of the excavated evidence at Sutterby Church. Only the femurs (upper leg bones) of the inhumation were recorded. The torso and head were outside the excavated area and the lower legs and feet had been cut away by later building works. The burial was dated by radiocarbon analysis to the mid eleventh to early thirteenth centuries.

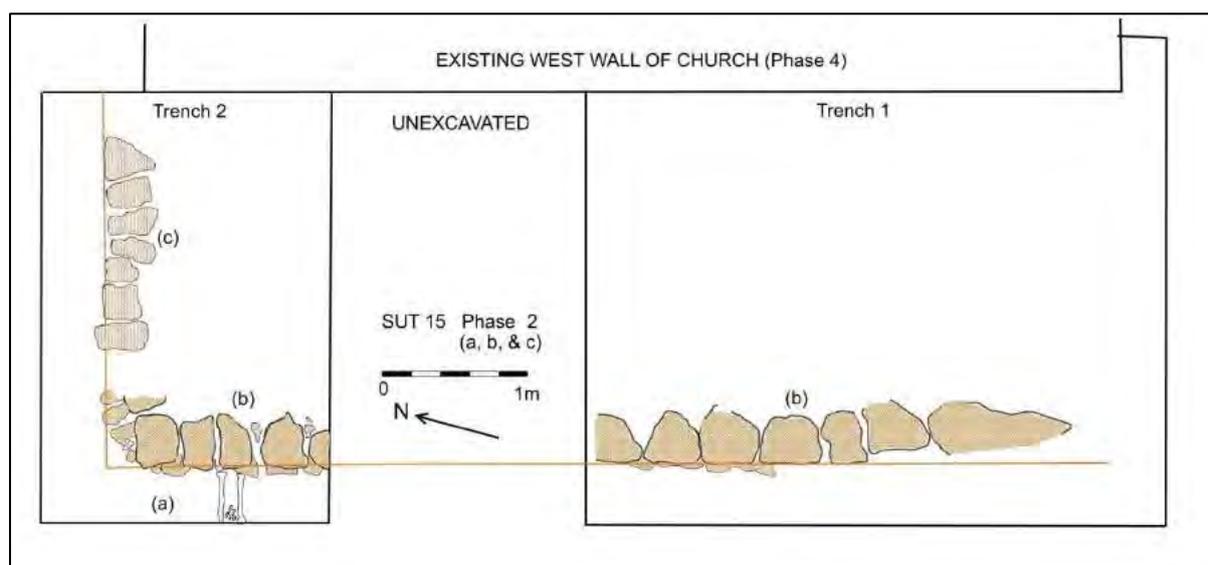
Fig. 16. Archaeological features relating to Phase 2 of the excavated evidence of Sutterby Church. Phase 2a is a possible levelling of the original cemetery ground surface. Phase 2b is the setting of a north-south stone foundation for the church. The inclusion of the east-west foundation is more speculative as the levels of 2b and 2c are not directly compatible. The position of the Phase 1 bones is shown for reference.

This phase has been divided into three sub-phases: 2a (possible ground levelling), 2b (north-south foundation) and 2c (east-west foundation). (Figure 16)

Phase 2c (east-west wall foundation) There is a similar row of roughly squared stones running east-west and potentially forming a foundation for the north wall. (Figures 16 and 17) These stones resemble the N-S row in form and appearance but sit at a slightly higher level (all are c. 10-15 cm higher than the N-S row). However, they are too high to form a base for a lost chamfered course belonging to Phase 3 (see below). On the basis of form they have been cautiously assigned to Phase 2.

There is a row of stones in the north wall which have been included as Phase 2c although their levels are not directly compatible with the Phase 2b footings. (Figures 16 and 17) Nor are the levels compatible for them to be a base for the lost Phase 3 chamfered blocks (if they ever existed?) but it should be borne in mind that these stones may belong to Phase 3.

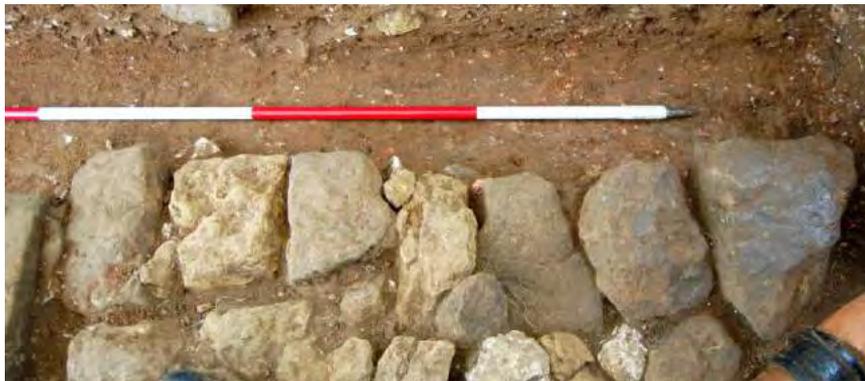
Fig. 17. The east-west row of roughly shaped stones forming a foundation for the north wall. They are similar in form to the north-south row which constitute phase 2b of the sequence and have been included as Phase 2c although their levels are not directly comparable. [Scale sections are 0.5m]

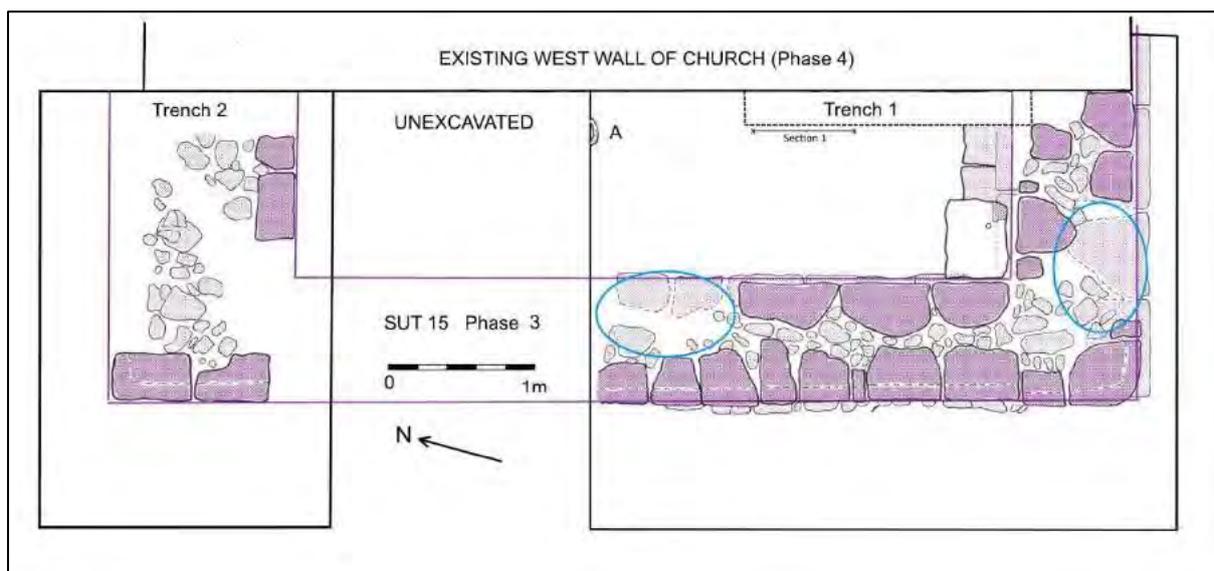
Fig. 18. The Phase 3 wall base has a row of chamfered blocks on its outer (west) elevation with faced blocks forming the inner wall. The main upper stones are shown in a darker shading with the lower blocks and rubble fill in a lighter shade. The two areas of stone robbing are outlined in blue.

west or south walls - c. 1.15m (not including the chamfer) compared with c. 0.7m for the west and south walls. (Figure 18)

An unusual feature was noted within the floor make up layers in the northern section of Trench 1. (Marked at 'A' on Figure 18) A partly globular concretion of reddish brown sandy material was noted containing a loose, greenish sandy sediment within. The concretion contained cm-sized fragments of chalk and was very heavy and hard but did not exhibit any signs of burning or human manufacture. The upper surface of the concretion was at 69.47m O.D. placing it at about 0.25m below the estimated floor level at that location. Samples were taken for geological inspection (see Appendix 5) and the analysis suggested a local hematite cementation of sub-floor deposits. The feature is illustrated below: (Figure 26)

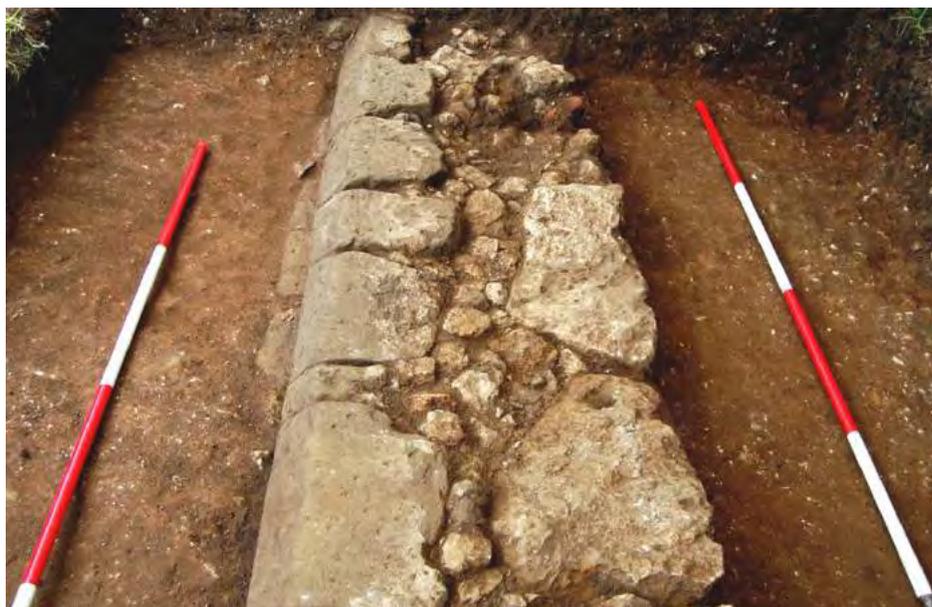
Fig. 19. Trench 1 looking north - Phase 3 wall base. Mortar stains were clearly visible on the upper surfaces of the worked masonry. The mortar in the rubble fill was still structurally sound. The chamfer was regular and well formed. [Scale divisions are 0.5m]

It was the discovery of this feature, found while searching for buried gravestones in 2014, that prompted the excavation. The top of the masonry was located between 0.25 - 0.30m below present ground level. Across Trenches 1 and 2 the ground level drops to the south by about 0.5m (about 1:16) and the wall follows this same gradient. The stones are mortared into place with rubble fill bound by mortar between the faces. Remnants of mortar are visible on the upper surfaces of the worked blocks. (Figure 19). The mortar is still hard and well-adhered to the blocks.

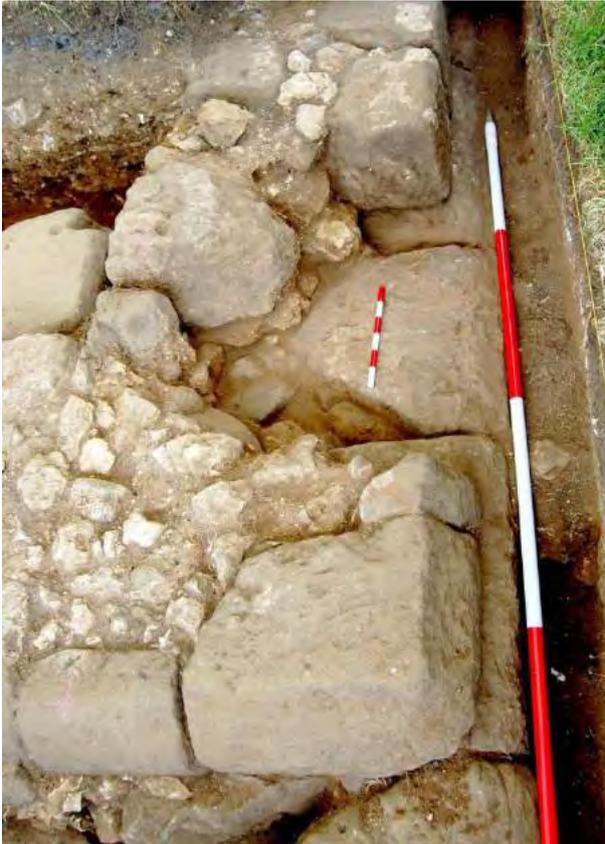
*Fig. 20. Trench 1 Phase 3 south wall, looking east. The robbed area in the south wall, showing the chamfered blocks to the west and the squared blocks to the east. The lower row of chamfered stones can be clearly seen.
[Large scale 2m, small scale 30cm]*

The robbed areas in Trench 1 were emptied and cleaned. The backfill of the robbed area in the south wall had material steeply inclined as if a hole had been dug, stone pulled out and the material dumped back in. The stones taken from this hole formed the join between chamfered blocks and squared blocks thus removing the evidence for how and where the transition was achieved. (Figure 20)

Phase 3 south wall: On the south side, the chamfered blocks sat on top of another chamfered course, but the limitations of the excavated area prevented seeing more of this masonry. (Figure 20) However, on the inner face of the wall, two courses of masonry acting as a stepped foundation, could be observed extending down from the level of the upper surface of the lower chamfered block.

As noted above, the upper course of chamfered blocks convert to plain squared blocks, but the method of this alteration is lost due to stone robbing. (Figure 20) There is no chamfer course visible in the present south wall of the church although it may well be there, but buried.

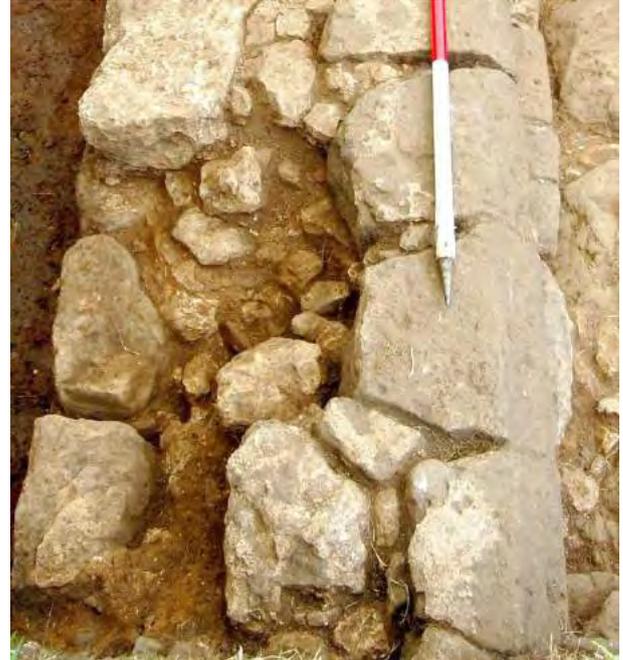
*Fig. 21. Trench 1 Phase 3 west wall, looking south. The robbed area in the west wall - faced inner blocks have been taken showing the stepped course beneath.
[Scale division 50cms]*

The robbed area in the west wall had removed faced internal blocks, giving a view of the slightly stepped-out course of masonry below. The contents of these robbed areas included lead came, iron nails and medieval pottery - these materials were ubiquitous in most of the excavated contexts. A clay pipe bowl datable to 1830-1850 was recovered from the fill of the west wall robber area (Figure 36) and there were fragments of thin hand-made brick thought to date to a 1740s repair programme in both pits. Although all of this is quite probably residual it does hint at the disturbances being in the nineteenth century.

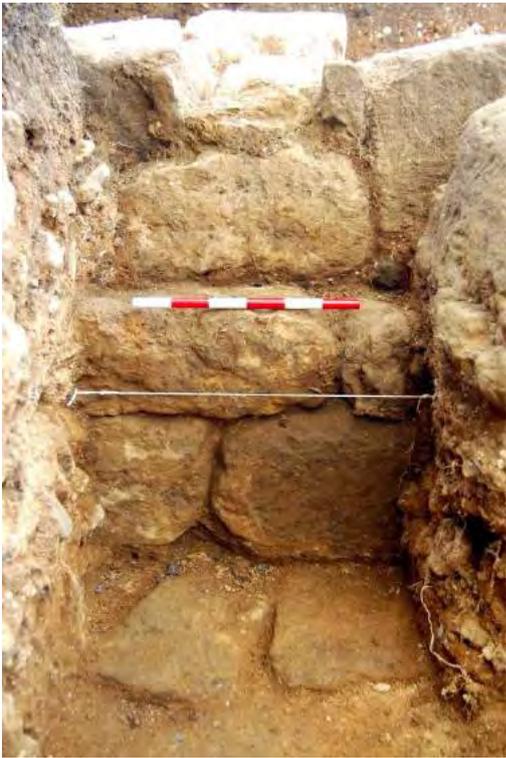
Fig. 22. Trench 1. Phase 3 wall looking south at the inner face of south wall just to east of the 'cornerstone'. On the external face the lower chamfered course begins at the level of the slight step (on which the scale sits). Internally there are two courses below this level, set on a footing. [Scale is 30 cm]

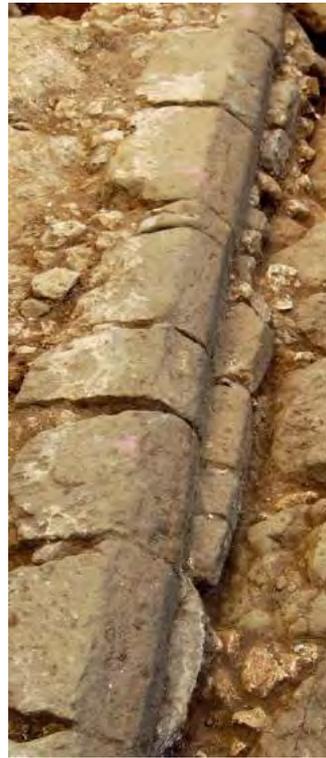
Fig. 23. Trench 1. Phase 3, looking south. A narrow, irregular step foundation underlay the chamfered blocks on the west side. [For scale c.f. Fig. 9]

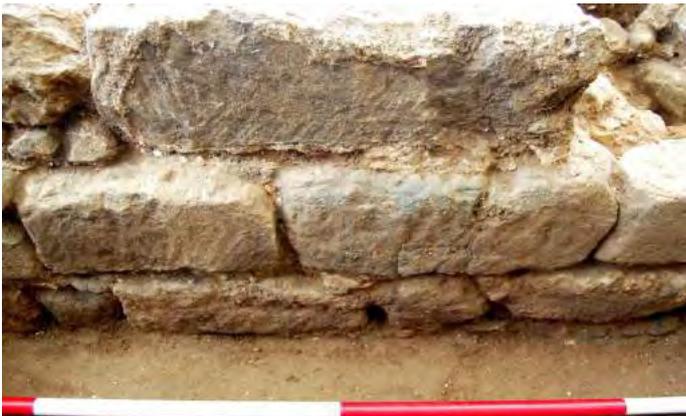
Fig. 24. Trench one, Phase 3, looking west. Part of the elevation of the inner face of the west wall. The faced blocks sit on a slight stepped foundation comprising two courses - a similar arrangement to that shown in Fig. 25. [Scale sections are 50cms]

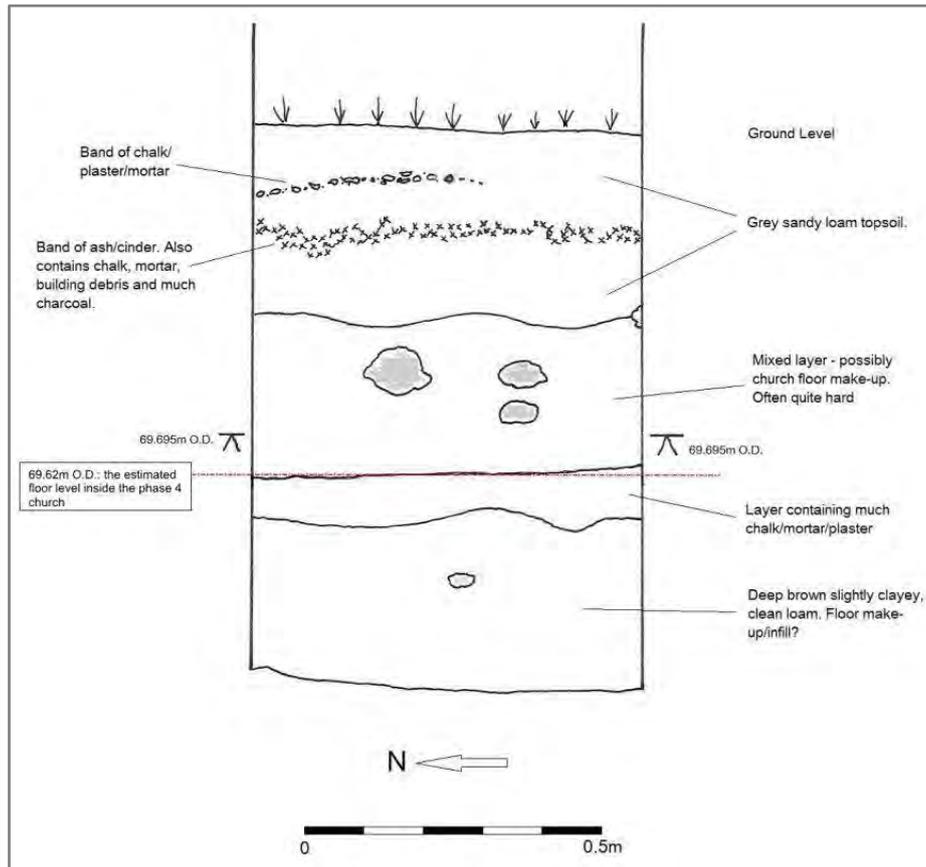
Fig. 25. Section 1 - west facing section showing stratigraphy in the floor make-up deposits inside the Phase 3 church. Estimated original floor level shown at 69.62m O.D. The position of section 1 is marked on the plan at Fig. 18.

The step foundation encountered around the walls is a good indicator of intended floor level, and the corner-stone is useful as it probably sat on the contemporary floor surface (although it could have been sunk into it). The heights of various indicators for possible floor levels including possible floor contexts (in metres O.D.) are listed below, and it should be remembered the floor slopes from north to south:

Level of step foundation (West wall)	69.73/69.70/69.67/69.62
Level of step foundation (South wall)	69.60
Base of 'Corner-stone'	69.62
Chalky/Mortar layer [043]	69.64/69.60/69.65
Compacted layer [044]	69.76/69.68

The structural features (stepped foundation and corner-stone), place floor level at 69.6m at the south west corner, rising to 69.7m around the middle of the nave. The potential earth floor deposit [044] gives slightly higher levels at 69.76/69.68 but in broadly the same area. It is possible the chalky/mortar layer [043] represents a construction/repair phase, but was too ephemeral for analysis. A section was drawn through the deposits inside of the church. (Figure 25)

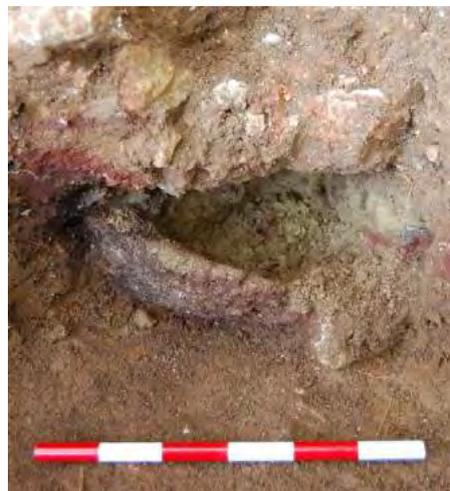
Fig. 26. The enigmatic concretion containing a green sand, located 0.3m below the estimated Phase 4 floor level. Geological analysis suggested it was a natural feature. [Scale is 0.3m]

The concretion may be entirely natural in its formation, but its position, central to the nave, is intriguing. Parsons has written on the presence of pits for 'holy' rubbish and soakaways for the water from piscina and fonts.¹⁷ Such features have been given the name *sacraria* and it

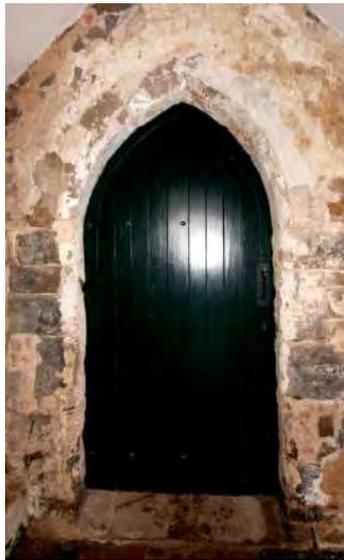
Fig. 27. The doorway in the south wall of the nave has a chamfered, two centred arch. It may date from a major re-modelling of the church in the late thirteenth or early fourteenth centuries.

Dating Phase 3: The building of the Phase 3 church is a substantial operation. The quality of the stonework and its working is good and probably represents a major reconstruction of the building. One of the broadly datable features of the church is its south door which is a two centred arch with a simple chamfer. (Figure 27) Doors of this type were popular from the mid thirteenth to the late fourteenth centuries and it is feasible that the rebuild of the church would have included the incorporation of this door. The earlier, round headed doorway may have been relocated into the north wall at this time.

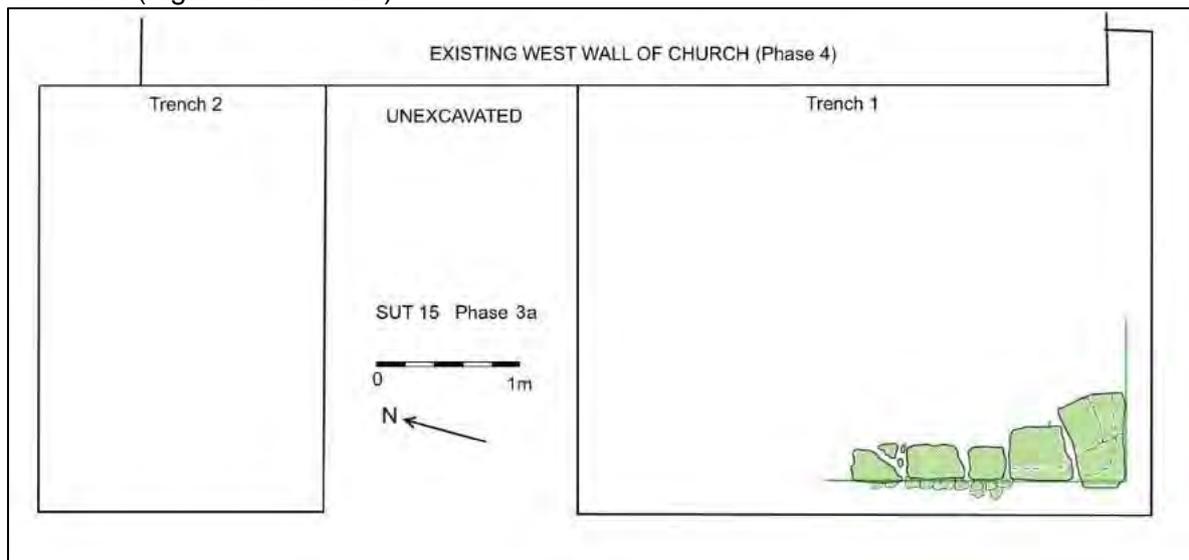
Fig. 28. Archaeological features included as Phase 3a comprise a row of stones, some chamfered, in the south of Trench 1, which could represent a fragment of wall. Whilst these stones may link to the lower masonry in the standing south wall, the poor quality of the masonry and its settings, and the lack of any other surviving elements of this feature, suggest it is more likely to represent an ephemeral repair or modification to Phase 3.

A row of masonry which is probably related to Phase 3; possibly a temporary or repair measure. (Figures 28 and 29)

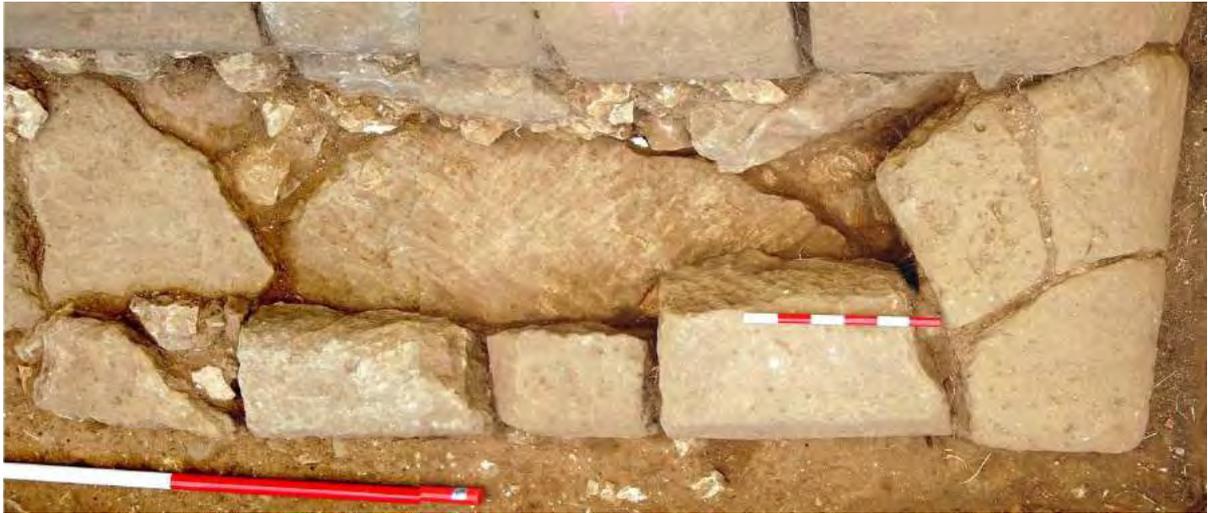
Fig. 29. The row of masonry comprising Phase 3a. It sits above the stones of Phase 2b and some blocks are chamfered. [North to the left. Small scale is 30cm. Joined photographs]

The row of five possible wall stones which form the basis for this phase are intriguing. As mentioned above, they do not sit together well as a masonry course and yet, when viewed down the south wall of the church (Figure 10), it seems quite possible that the south wall is founded on this phase of masonry which forms a lower chamfered plinth visible along the excavated portion of the south wall. These stones were initially thought to represent a separate building phase, but on reconsideration, the idea does not hold up. The only convincing stone in this context is the corner stone. Although broken into three segments, it still displays a shallow but heavily worn chamfer on its south and west edges. The second stone in the row is reasonably substantial and chamfered, but the chamfer is more similar to that on the Phase 3 masonry and does not match the corner stone. The third stone is insubstantial but appears to have a slight chamfer on both its north and west faces. The fourth stone is a roughly shaped block and the fifth is similar but fragmentary. There are no other surviving stones from this course in Trenches 1 or 2 and there are no footings for additional stones. The five blocks teeter on the edge of the Phase 2 stones below them, while their western edge exhibits a rather odd substrate of small chalk lumps. (Figure 30)

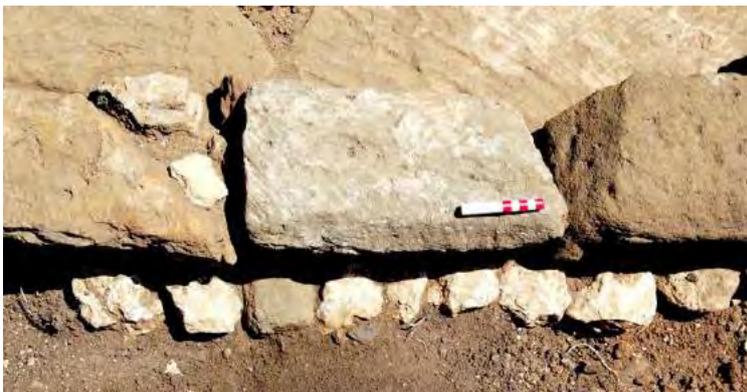
Fig. 30. Stones 5, 4 and 3 of the Phase 3a masonry shown in the foreground, sitting on a row of small irregular chalk cobbles. The Phase 2 stones beneath are visible in the background. [North to the left. Scale is 10cm]

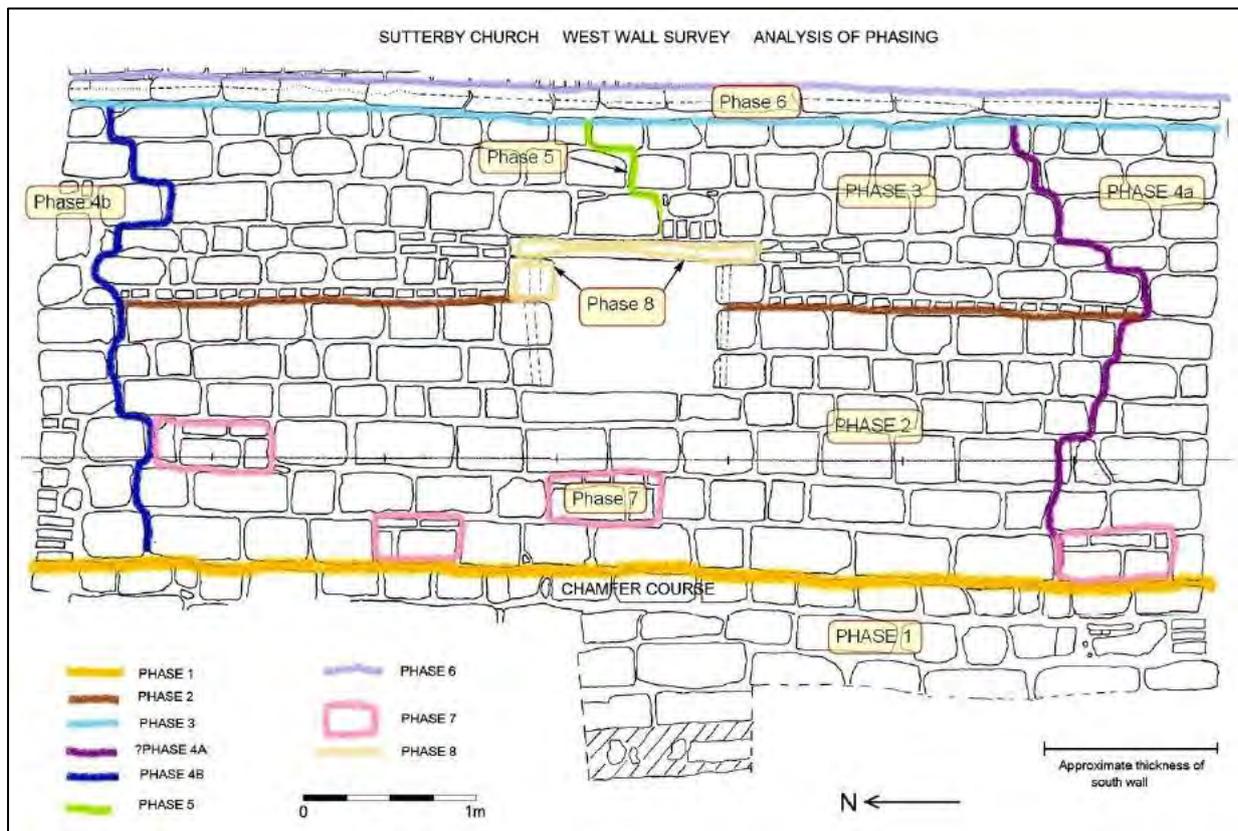
Fig. 31. Survey of the standing west wall of Sutterby Church showing many phases of repair and alteration. The first phase of this sequence (Phase 1) equates to Phase 4 of the excavation sequence. The dating of the phases is given in the table above.

wall, as viewed today, is complex with several phases of repair and alteration in its structure. The wall was drawn and analysed in 2015 and a survey drawing giving suggested phases was made.¹⁸ (Figure 31) On that drawing, Phase 1 of the wall is equivalent to Phase 4 of the excavation.

Phase 1 - original rebuild of west wall in present position	1600s
Phases 2 & 3 - rebuild of west wall from chamfer up	1743
Phases 4a & 4b - collapse and repairs of corners	mid to late 1800s
Phase 5 - lintel failure	mid to late 1800s
Phase 6 - string course and rebuild of gable in brick (and re-roof)	mid to late 1800s
Phase 7 brick repairs replaced in stone	1980
Phase 8 repairs to west window	2011

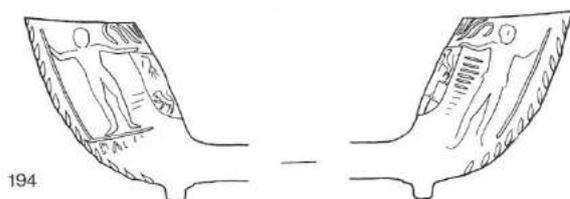
Fig. 36. Decorated clay pipe bowl of 'standing native' type with arms of Prussia on rear and banners below the figures - one containing 'LINC' other containing 'HURST' or 'NURST'. Dated to 1830-50. Probably a Lincoln product

Amongst the pottery collected, was a decorated clay pipe bowl, found in the area of stone robbing on the west wall. It is datable to 1830-50 and is probably from Lincoln. A very similar bowl, found in Lincoln, is illustrated.²² (Figure 36)

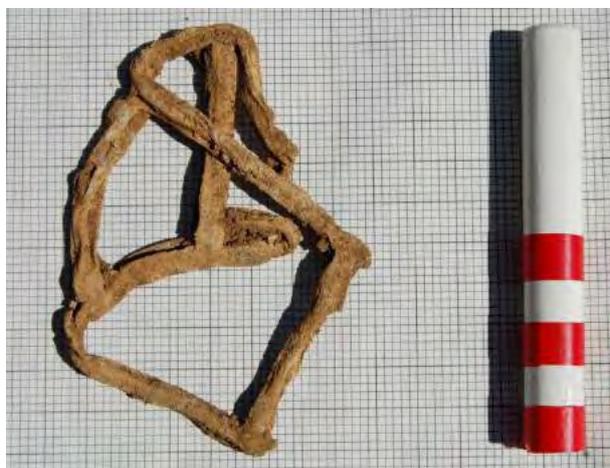
Fig. 37. Piece of articulated lead window came found in [027]. When found, there were still fragments of glass in the lead. [Scale 10cm]

As with the window glass the lead comes were mixed throughout the deposits below the Phase 3 and Phase 4 windows. Most were fragmentary, but there was one larger piece, still with some glass *in situ*, found in [027] which was a layer above the floor level inside the Phase 3 church. (Figure 37)
