SPIRIT OF SUTTERBY PROJECT

Report on an Archaeological Excavation at Sutterby Church

23rd - 30th May 2015

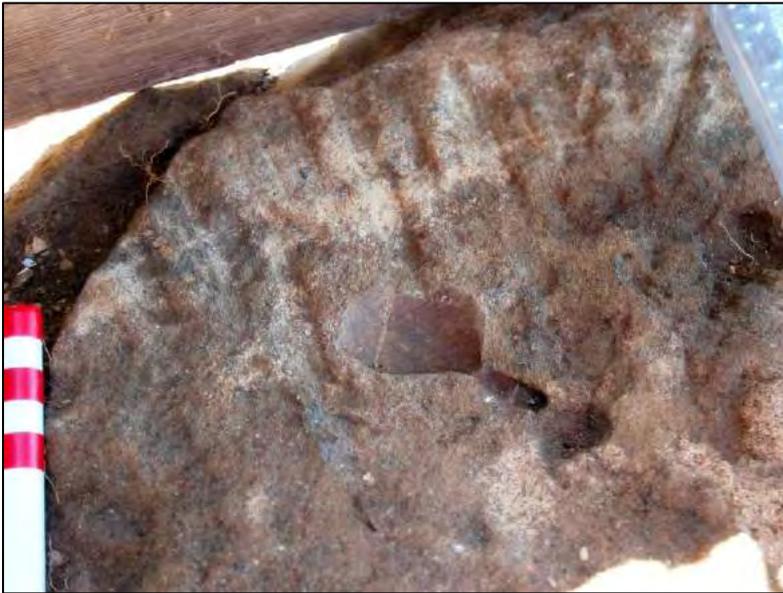
Fig. 38. Stone tooling marks made with a claw, visible on the upper surface of stone 5. [Scale is 10 cms]

- There were several types of tooling identified - in particular most stones showed marks of a broad bladed tool without teeth (unornamented), but there was also a group dressed with a claw tool with broad teeth and narrow gaps (Figure 38). This may represent two phases of building, one pre c. 1200 and one post c. 1200.
- Some stones might exhibit both types of working suggesting re-dressing of masonry for reuse.
- It may be possible to measure tool blade width from the photographs and define different tooling groups.

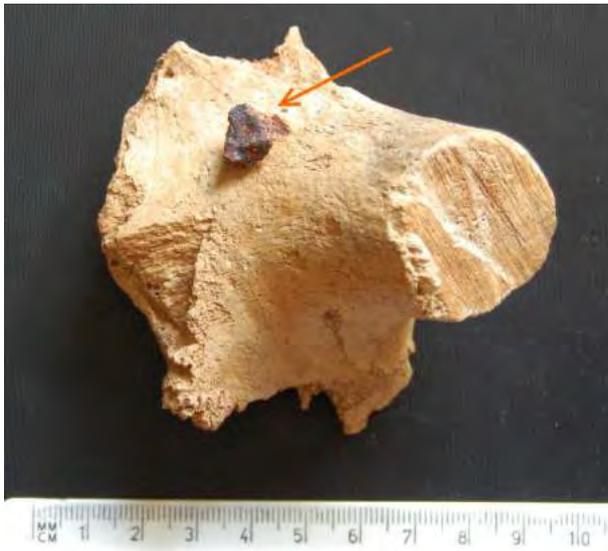
Fig. 39. Fragment of animal skull, probably sheep, showing horn sawn through and snapped at base and an iron nail (arrowed) hammered through the bone. [Scale in cms]

Context [016] contained an unusual piece; a fragment of skull, probably from a sheep, showing the horn base sawn through and snapped off, but also with a square-shanked iron nail piercing the horn base and cranium. Was this once part of a trophy on display, and the horn removed later? (Figure 39)

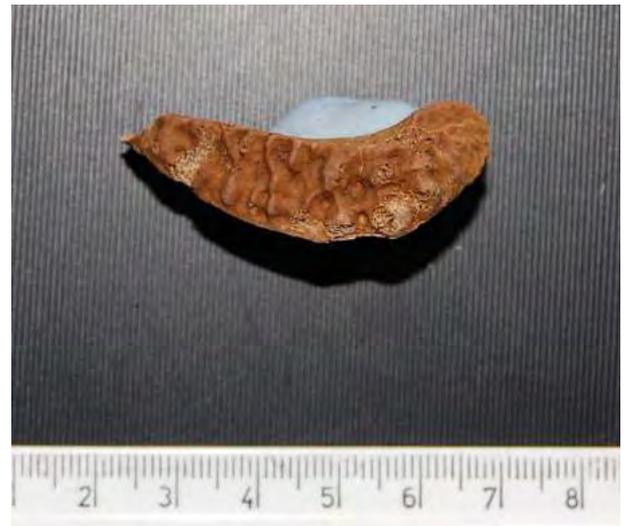
Fig. 40. The face of the right pubic symphysis found in [050]. The billowing ridges across the surface, with no boundaries, suggests the individual was 15-24 years of age at death. [Scale in cms]

Most of the human bone was found in Trench 2 in the lower contexts [046] and [050]. (Figure 41) These were close to the truncated inhumation noted as Phase 1 above and probably derive from the same construction activity evidenced by the stone footings of Phase 2b. (Figures 12 and 13) The material recovered from these contexts included fragments of skull (maxilla and zygoma), pelvis, ribs, vertebra, clavicle, femur, humerus, radius, metacarpals and phalanges. No bones were diagnostic for the sex of the individual(s) concerned. One bone (pubic symphysis in [050]) was diagnostic for age at death, giving a figure of 15 - 24 years.²⁶ (Figure 40)

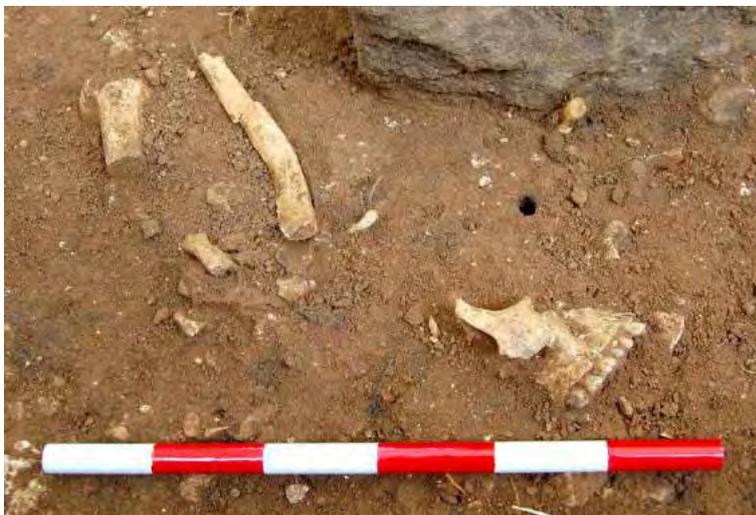
Fig. 41. Context [046] in Trench 2, showing the scatter of disarticulated human remains close to the north west corner of the Phase 2b footings. Pieces of skull, rib, humerus and metacarpal are visible. [Scale is 30cm]

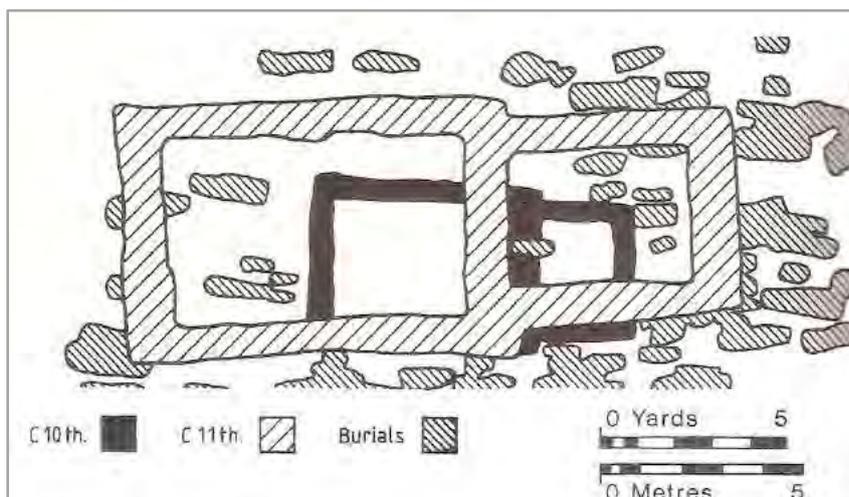
Fig. 42. The later church at Raunds (Northants) cuts through the burials in the earlier graveyard (after Boddington - see n.37)

The years following the Norman conquest are thought to have been a time of great church building: Morris asserts: 'The years 1050-1150 witnessed a great rebuilding when almost all churches were reconstructed in stone'.³⁶ At Raunds in Northamptonshire Boddington has shown the smaller tenth century church overlain by the larger eleventh century church, cutting through earlier burials just as at Sutterby.³⁷ (Figure 42)

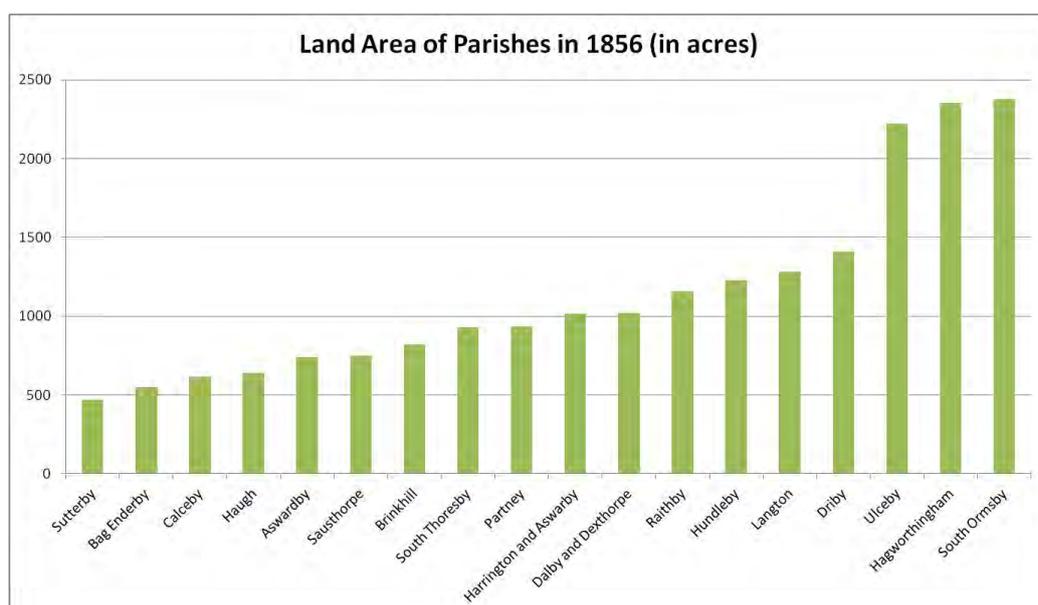
Fig. 44. The land area of Sutterby parish and the seventeen parishes surrounding it, as given in White's 1856 Directory of Lincolnshire. Sutterby is the smallest in the group.

It is evident that Sutterby remitted the smallest return in the 1334 tax. As noted earlier (Sections 1.1 and 1.2) the size of the estate in the Lindsey Survey (1115-1118) is around 300 acres and the eventual size of the parish is 471 acres. This is a small parish. If we look at the land area of the same group of parishes (in 1856) we see that, once again, Sutterby is the smallest of the group.⁵¹ (Figure 44)

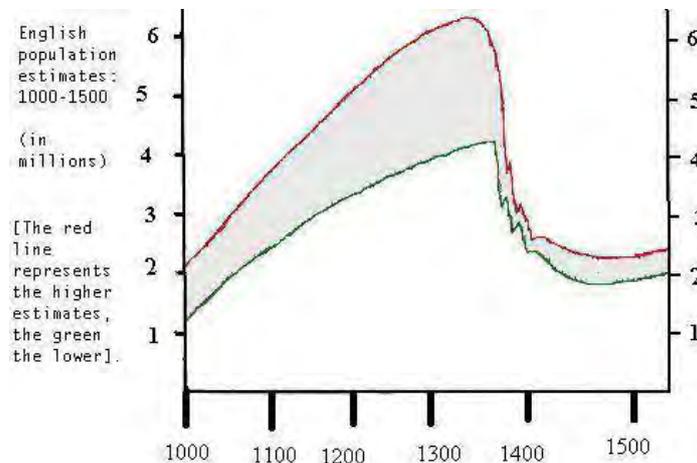
Fig. 45. Population decline in the fourteenth century, based on Hatcher, 1977.

Some might argue 'size doesn't matter' but when it comes to economic sustainability, it does. As Sutterby entered the fourteenth century, the great boom in population and prosperity that had characterised the 1100s and 1200s was about to end. In the second decade of the fourteenth century a famine (due to a climatic 'blip') severely weakened the population, and before they could fully recover from it, disease (the Black Death of 1349/50) swept the country killing nearly half the population. By the 1380s there were not enough people left to populate and farm England's villages. (Figure 45 after Hatcher⁵²)

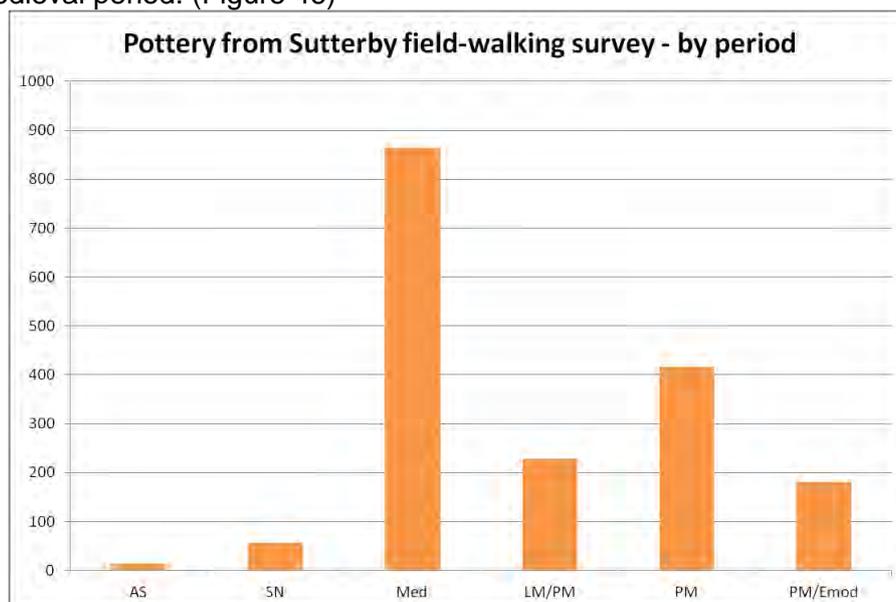
Fig. 46. The combined results of fieldwalking surveys in the area around Sutterby Church, showing medieval growth and subsequent decline. Pottery quantities are not directly proportional to population numbers (under-represented earlier, over-represented later) but are a useful indication of population and activity trends. [Axes show numbers of sherds collected against period]

Life in the village continues through post medieval and into modern times, but in a much reduced state, and it would probably be more correct to refer to Sutterby as a hamlet from the post medieval period. (Figure 46)
